TEST REPORT

Report No.	L0503(E)/62	
Operation No.	6206BL0543	
Name and address of customer	LEGO ELECTRIC CO.,LTD. 72/127 Somdetphrachaotaksin Rd, Bukkhalo, Thonburi Bangkok 10600	
Sample description	Sample was submitted and identified by/on behalf of the customer as following:  ELECTRICAL PLASTIC ENCLOSURES  Trademark: PRI PRODUCTS  Model: ML1  Size: 140X78X50mm  1 set (1unit)	
Sample No.	BL0543	
Sample characteristic and condition	Normal	
Sample received date	June 28, 2019	
Test date	July 4, 2019 – July 5, 2019	
Issue date	July 9, 2019	
Test standard	IEC 60529:2001 (IP54)	
Test report	Details of the test report as shown on the following pages.	
Summary of testing	The test results comply with standard	
Tested by (name + signature)	Mr. Sutikorn Martdoug	 
Approved by (name + signature)	Mr. Rachen Muongon	 
Certified by (name, function + signature)	Mr. Arthit Wussanamongkol Division manager, Operation division 1

The sample was tested and complies with the IP54 requirement, Protection against access to hazardous parts, Protection against solid foreign objects and Protection against water test.

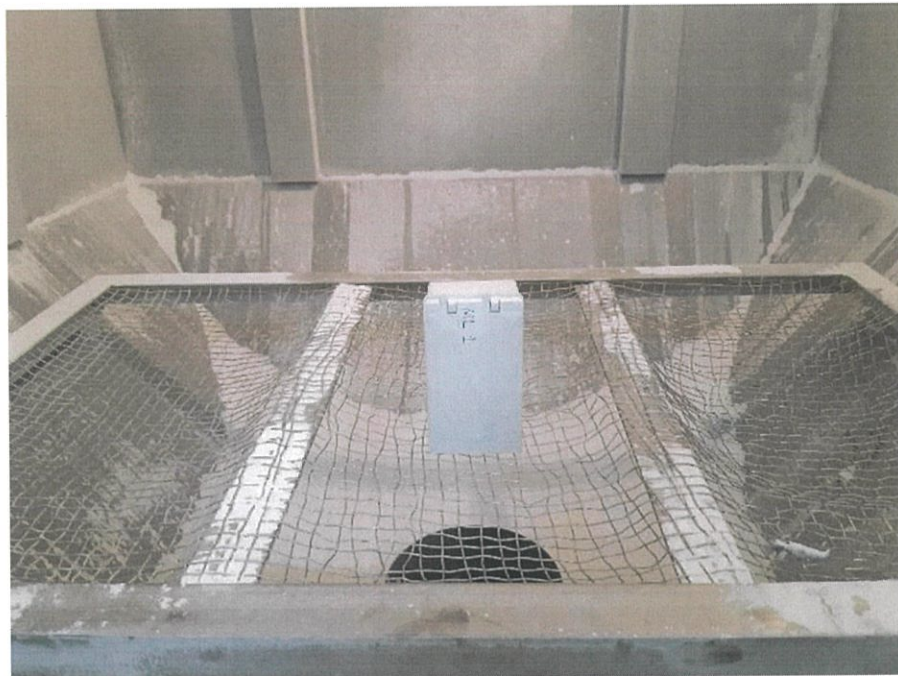
Photo No.4 : IP5X Dust test

The enclosure under test is supported in its normal operating position inside the test chamber, but is not connected to a vacuum pump and test shall be continued for a period of 8 h.

The test is made using a dust chamber incorporating the basic principles show in figure 2 of IEC 60529:2001 whereby the powder circulation pump may be replaced by other means suitable to maintain the talcum powder in suspension in a closed test chamber. The talcum powder used shall be able to pass through a square-meshed sieve the nominal wire diameter of which is 50  $\mu\text{m}$  and the nominal width of a gap between wires 75  $\mu\text{m}$ . The amount of talcum powder to be used is 2 kg per cubic metre of the test chamber volume.

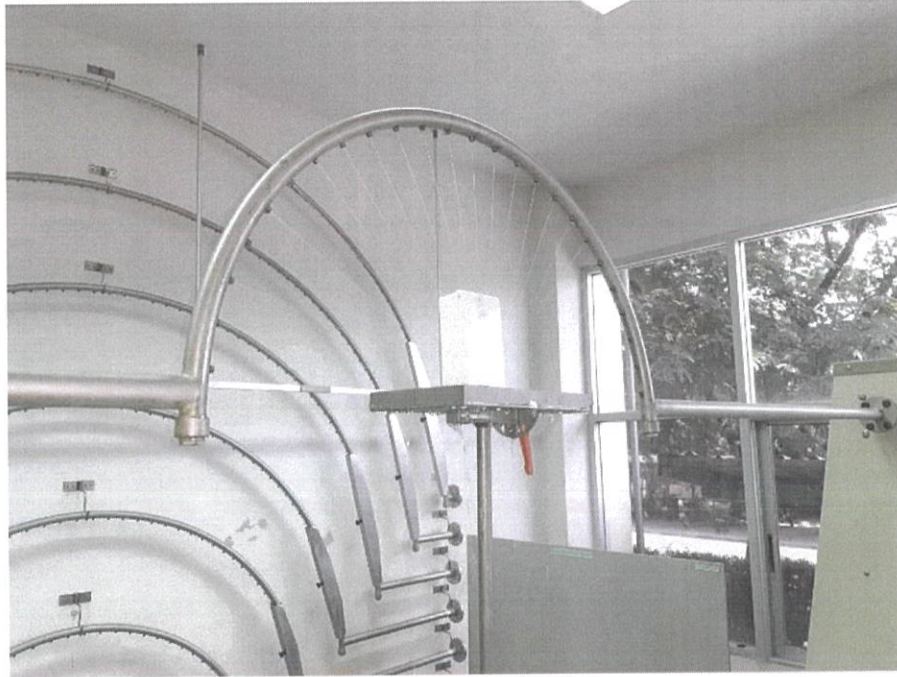
Photo No.5 : IPX4 Water test

The test is made using of test devices described in figure 4 The oscillating tube has spray holes over the whole 180° of the semicircle and total flow rate is adjusted as specified in table 9 of IEC 60529:2001

The tube is caused to oscillate through an angle of almost 360°, 180° on either side of the vertical, the time for one complete oscillation being about 12 s. The test duration of the test is 10 min.

The support for the enclosure under test is perforated so as to avoid acting as a baffle and the enclosure is sprayed from every direction by oscillating the tube to the limit of its travel in each direction.

The tube radius is 400 mm.

The flow rate is 1.10 lite/min.

Distance from spray holes to enclosure surface 200 mm.

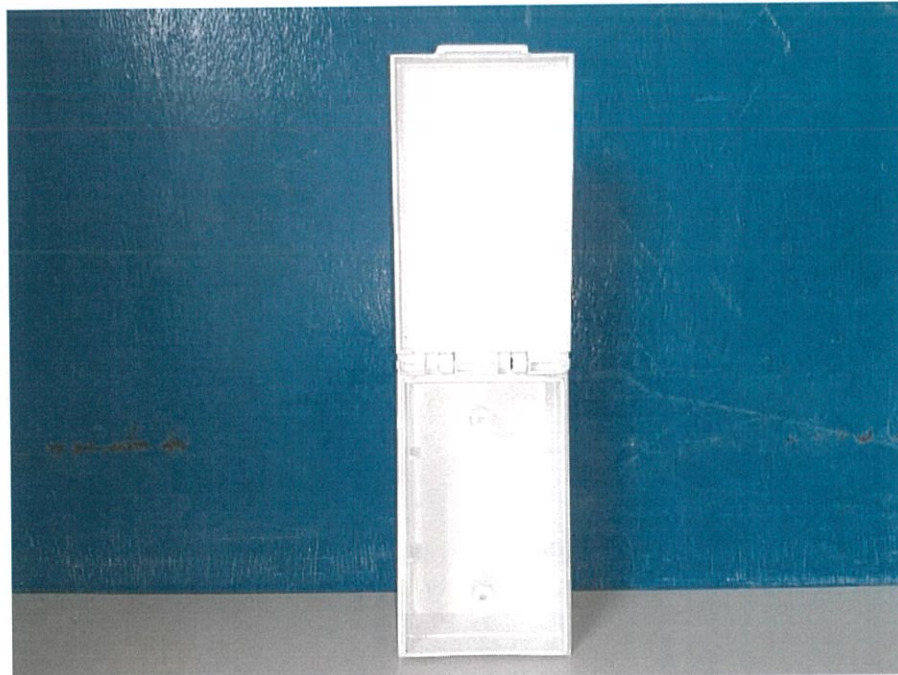
Photo No.6 : After test

Degree of protection			Result / Remark	Verdict	
Degree	Test	Definition			
IP54		Protected against access to hazardous parts with a wire	The access probe of 1.0 mm $\emptyset$ shall not penetrate	The access probe of 1.0 mm $\emptyset$ , not penetrate to the enclosure.	P
	IP5X	Dust-protected	Ingress of dust is not totally prevented, but dust shall not penetrate in quantity to interfere with satisfactory operation of the apparatus or to impair safety	No dust was found inside the enclosure.	P
	IPX4	Protected against splashing water	Water splashed against the enclosure from any direction shall have no harmful effects.	No water was found inside the enclosure.	P

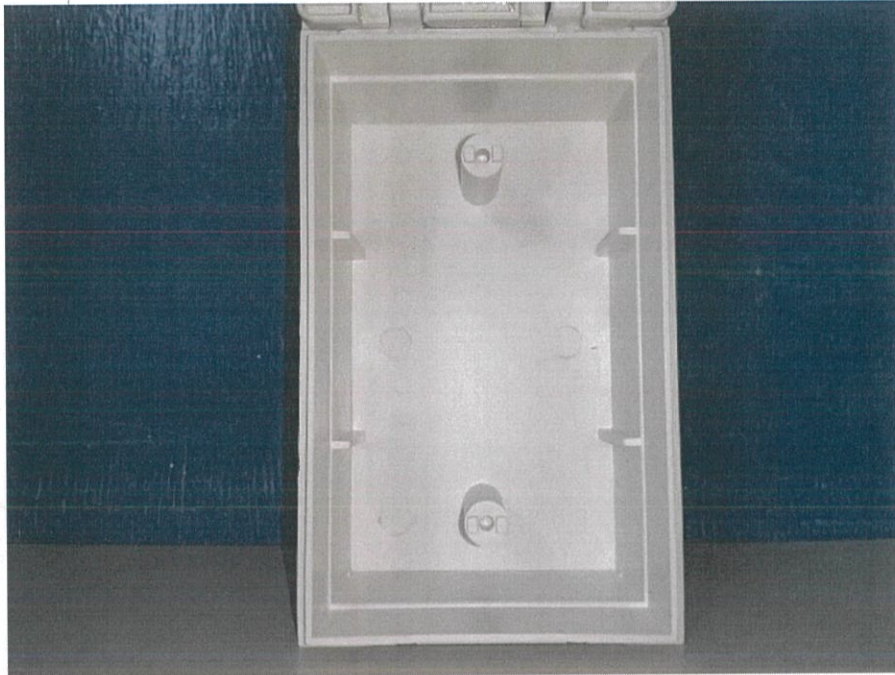
Photo No.7 : After test

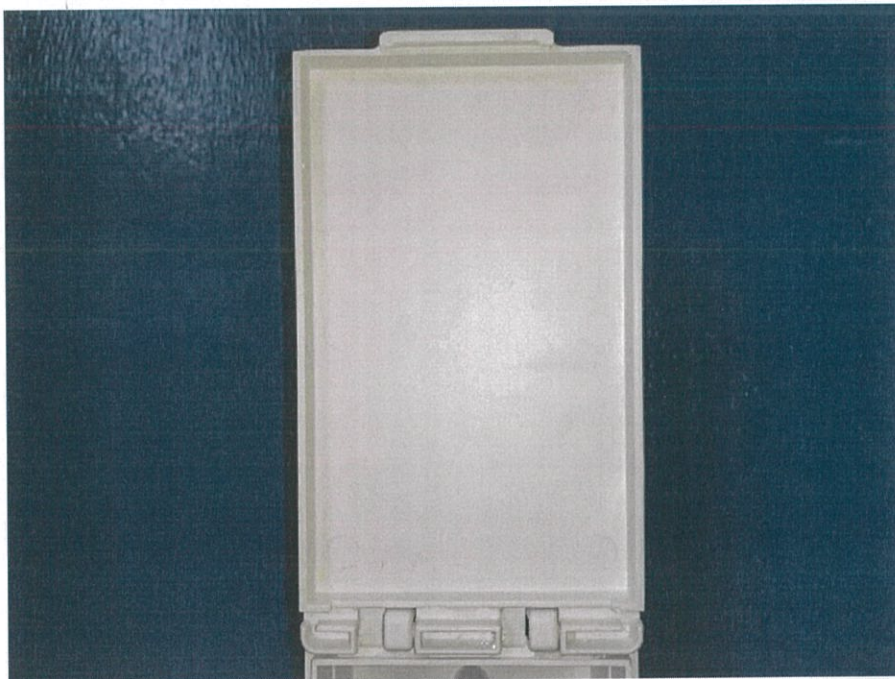
Photo No.8 : After test

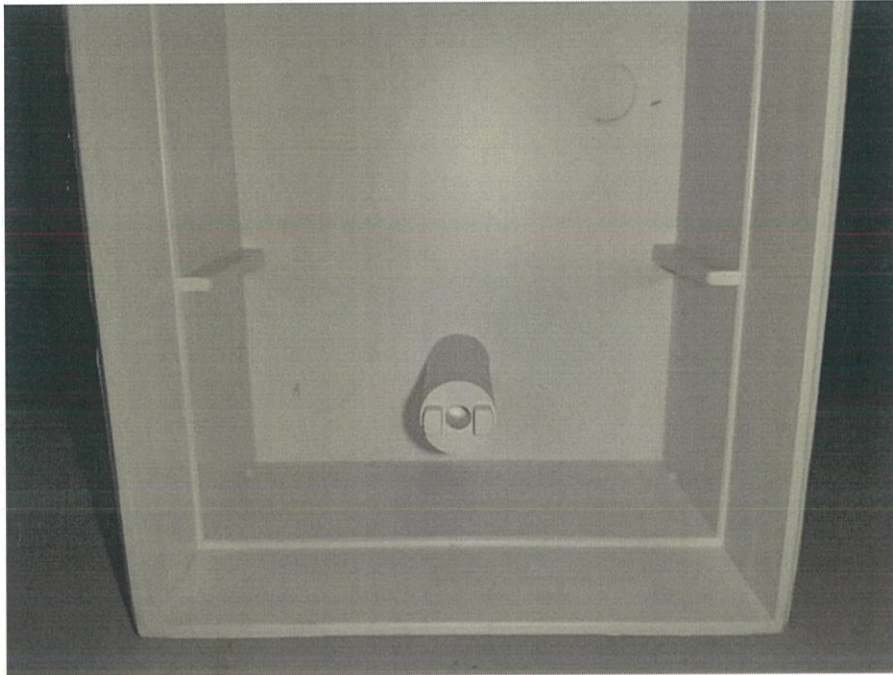
Photo No.9 : After test

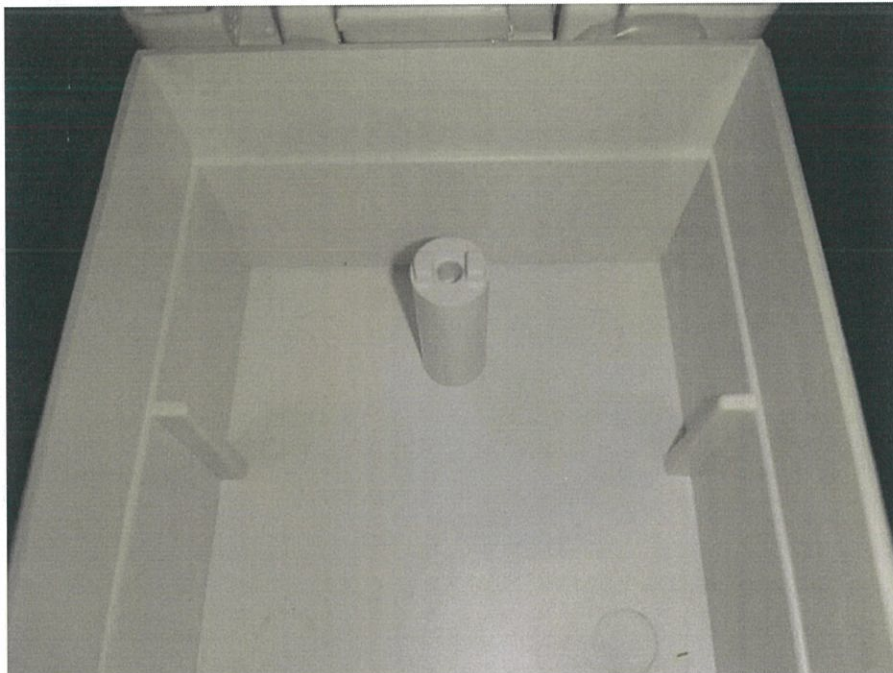
Photo No.10 : After test
