TEST REPORT

Report No.	L0561(E)/62	
Operation No.	6207BL0591	
Name and address of customer	SEANG NGARM GROUP (2535) CO., LTD. 123-125-127 Chakawat rd. Samphantawong, Samphantawong Bangkok 10100	
Sample description	Sample was submitted and identified by/on behalf of the customer as following: ELECTRICAL PLASTIC ENCLOSURES Trademark: PRI PRODUCTS Model: ML2 Size: 85X127X50mm 1 set (1unit)	
Sample No.	BL0591	
Sample characteristic and condition	Normal	
Sample received date	July 23, 2019	
Test date	August 5, 2019 – August 7, 2019	
Issue date	August 15, 2019	
Test standard	IEC 60529:2001 (IP54)	
Test report	Details of the test report as shown on the following pages.	
Summary of testing The test results comply with standard		
Tested by (name + signature)	Mr. Nopparat Charoen	 
Approved by (name + signature)	Mr. Rachen Muongon	 
Certified by (name, function + signature)	Mr. Arthit Wussanamongkol Division manager, Operation division 1

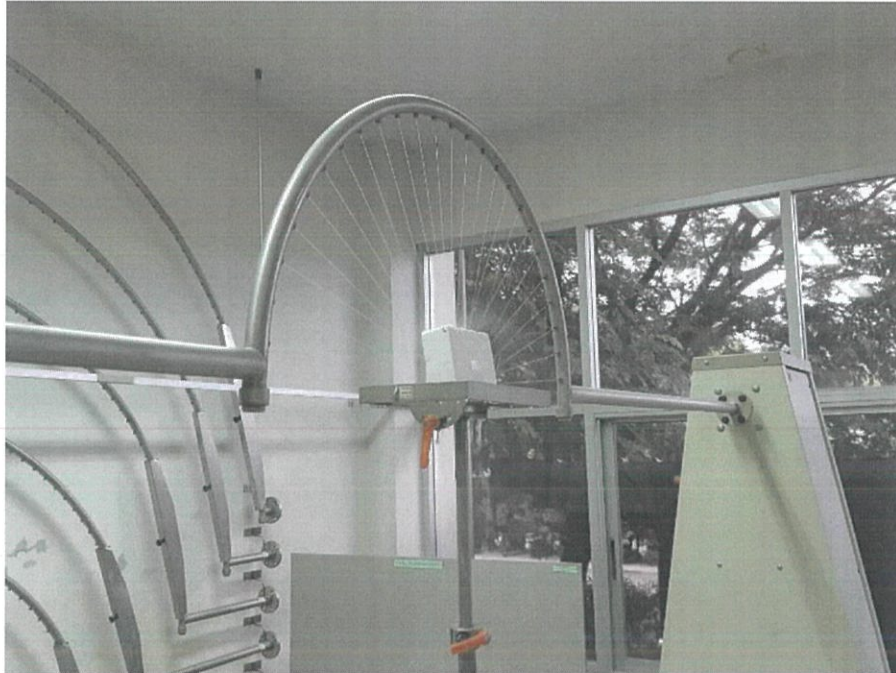
Photo No.5 : IPX4 Water test

Protected against splashing water test (IPX4)

The test is made using of test devices described in figure 4 The oscillating tube has spray holes over the whole 180° of the semicircle and total flow rate is adjusted as specified in table 9 of IEC 60529:2001

The tube is caused to oscillate through an angle of almost 360°, 180° on either side of the vertical, the time for one complete oscillation being about 12 s. The test duration of the test is 10 min.

The support for the enclosure under test is perforated so as to avoid acting as a baffle and the enclosure is sprayed from every direction by oscillating the tube to the limit of its travel in each direction.

The tube radius is 400 mm.

The flow rate is 1.80 lite/min.

Distance from spray holes to enclosure surface 200 mm.
