TEST REPORT

Report No.	L0562(E)/62	
Operation No.	6207BL0592	
Name and address of customer	SEANG NGARM GROUP (2535) CO., LTD. 123-125-127 Chakawat rd. Samphantawong, Samphantawong Bangkok 10100	
Sample description	Sample was submitted and identified by/on behalf of the customer as following: ELECTRICAL PLASTIC ENCLOSURES Trademark: PRI PRODUCTS Model: PRI201 Size: 75X125X50mm 1 set (1unit)	
Sample No.	BL0592	
Sample characteristic and condition	Normal	
Sample received date	July 23, 2019	
Test date	August 5, 2019 – August 7, 2019	
Issue date	August 15, 2019	
Test standard	IEC 60529:2001 (IP54)	
Test report	Details of the test report as shown on the following pages.	
Summary of testing	The test results comply with standard	
Tested by (name + signature)	Mr. Nopparat Charoen	 
Approved by (name + signature)	Mr. Rachen Muongon	 
Certified by (name, function + signature)	Mr. Arthit Wussanamongkol Division manager, Operation division 1

The sample was tested and complies with the IP54 requirement, Protection against access to hazardous parts, Protection against solid foreign objects and Protection against water test.

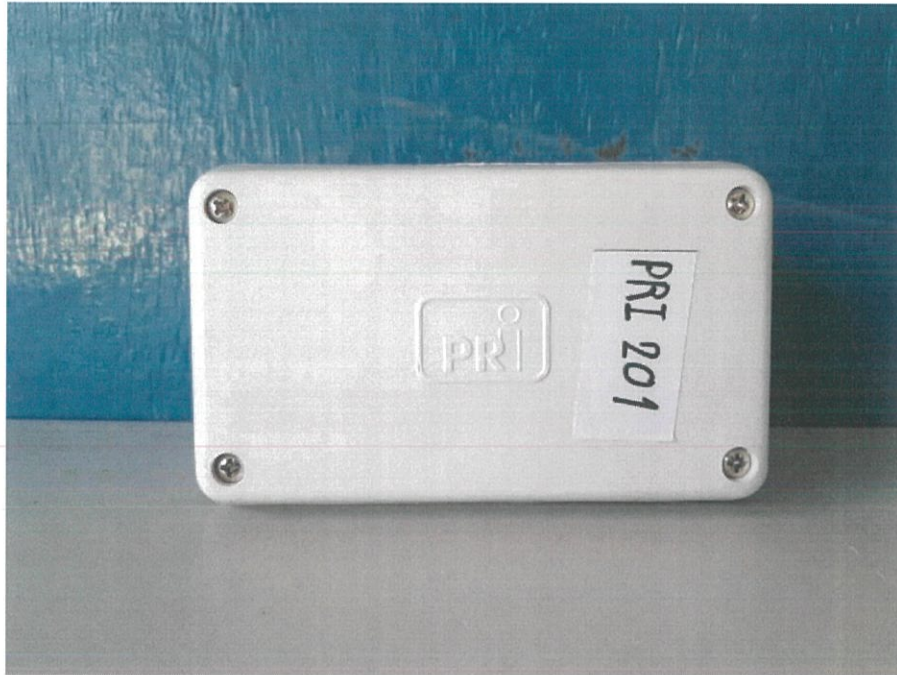
Photo No.1 : Front view

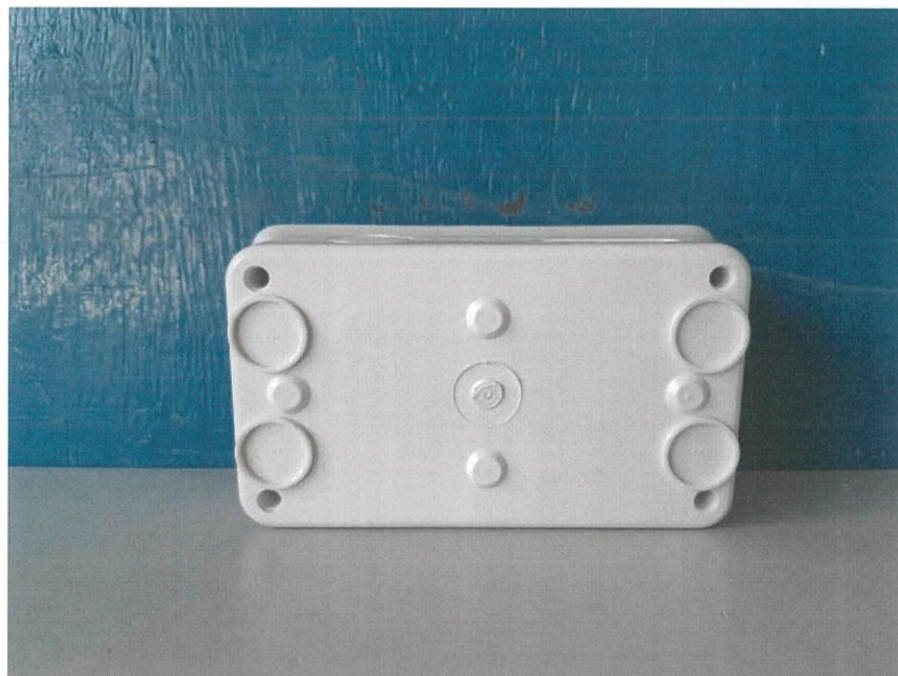
Photo No.2 : Back view

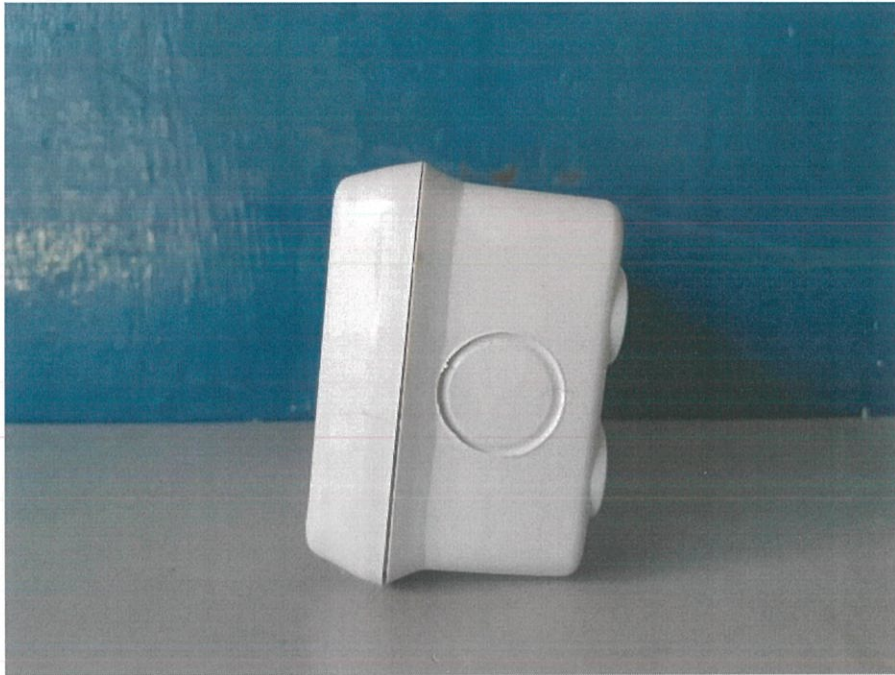
Photo No.3 : Side view

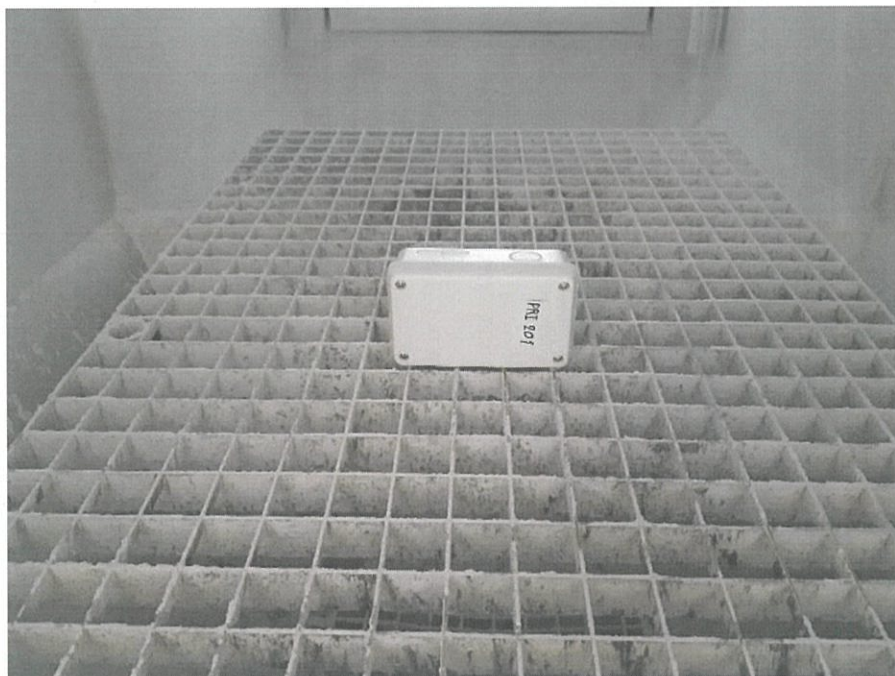
Photo No.4 : IP5X Dust test

The enclosure under test is supported in its normal operating position inside the test chamber, but is not connected to a vacuum pump and test shall be continued for a period of 8 h.

The test is made using a dust chamber incorporating the basic principles show in figure 2 of IEC 60529:2001 whereby the powder circulation pump may be replaced by other means suitable to maintain the talcum powder in suspension in a closed test chamber. The talcum powder used shall be able to pass through a square-meshed sieve the nominal wire diameter of which is 50  $\mu\text{m}$  and the nominal width of a gap between wires 75  $\mu\text{m}$ . The amount of talcum powder to be used is 2 kg per cubic metre of the test chamber volume.

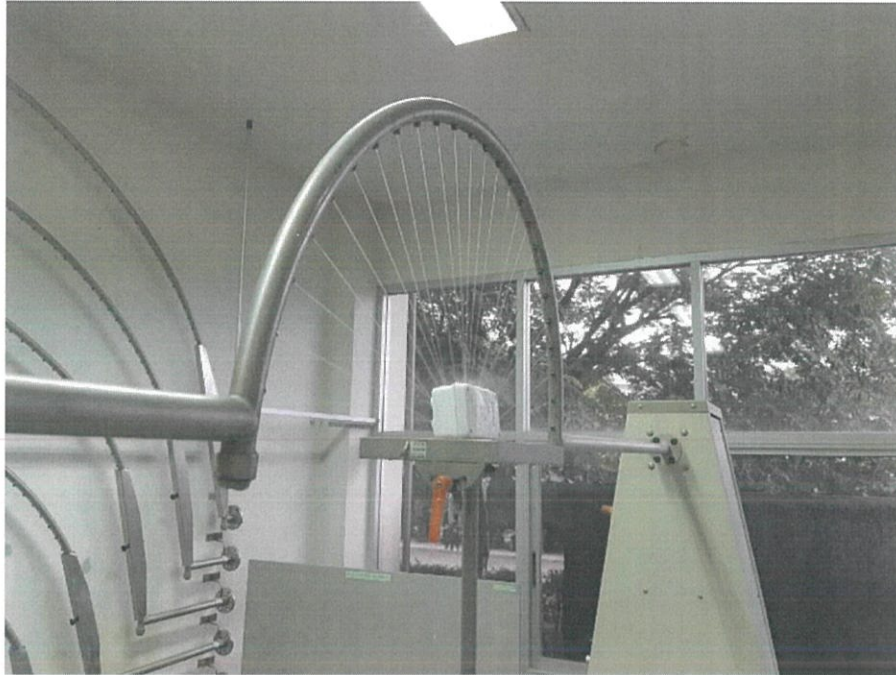
Photo No.5 : IPX4 Water test

The test is made using of test devices described in figure 4 The oscillating tube has spray holes over the whole 180° of the semicircle and total flow rate is adjusted as specified in table 9 of IEC 60529:2001

The tube is caused to oscillate through an angle of almost 360°, 180° on either side of the vertical, the time for one complete oscillation being about 12 s. The test duration of the test is 10 min.

The support for the enclosure under test is perforated so as to avoid acting as a baffle and the enclosure is sprayed from every direction by oscillating the tube to the limit of its travel in each direction.

The tube radius is 400 mm.

The flow rate is 1.80 lite/min.

Distance from spray holes to enclosure surface 200 mm.

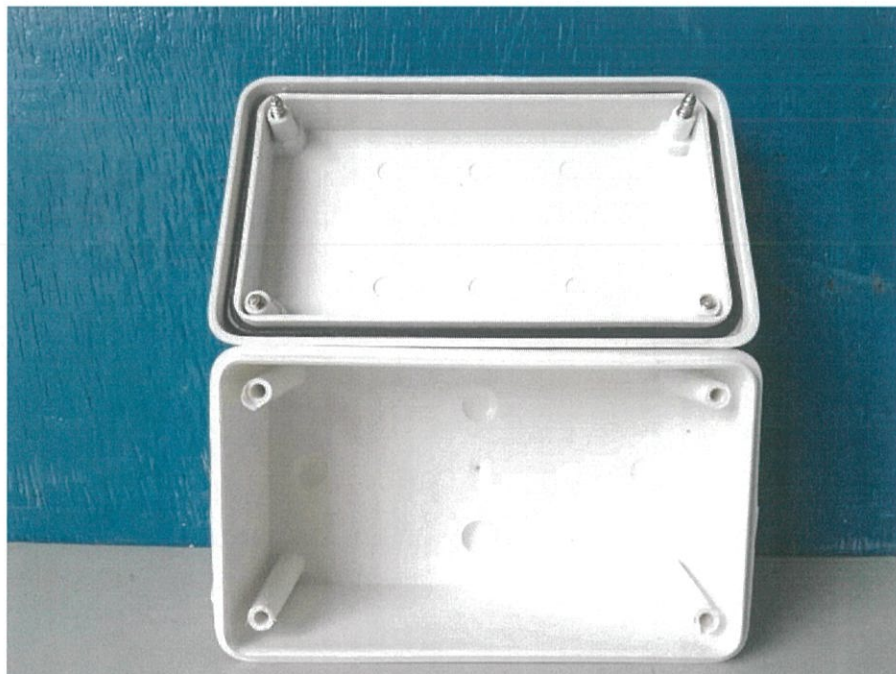
Photo No.6 : After test

Degree of protection		Result / Remark	Verdict
Degree	Test	Definition			
IP54		Protected against access to hazardous parts with a wire	The access probe of 1.0 mm $\varnothing$ shall not penetrate	The access probe of 1.0 mm $\varnothing$ , not penetrate to the enclosure.	P
	IP5X	Dust-protected	Ingress of dust is not totally prevented, but dust shall not penetrate in quantity to interfere with satisfactory operation of the apparatus or to impair safety	No dust was found inside the enclosure.	P
	IPX4	Protected against splashing water	Water splashed against the enclosure from any direction shall have no harmful effects.	No water was found inside the enclosure.	P
