TEST REPORT

Report No.	L0560(E)/62	
Operation No.	6207BL0590	
Name and address of customer	SEANG NGARM GROUP (2535) CO., LTD. 123-125-127 Chakawat rd. Samphantawong, Samphantawong Bangkok 10100	
Sample description	Sample was submitted and identified by/on behalf of the customer as following: ELECTRICAL PLASTIC ENCLOSURES Trademark: PRI PRODUCTS Model: PR4 Size: 350X510X180mm 1 set (1 unit)	
Sample No.	BL0590	
Sample characteristic and condition	Normal	
Sample received date	July 23, 2019	
Test date	August 8, 2019 – August 8, 2019	
Issue date	August 15, 2019	
Test standard	IEC 60529:2001 (IP44)	
Test report	Details of the test report as shown on the following pages.	
Summary of testing	The test results comply with standard	
Tested by (name + signature)	Mr. Nopparat Charoen	
Approved by (name + signature)	Mr. Rachen Muongon	
Certified by (name, function + signature)	Mr. Arthit Wussanamongkol Division manager, Operation division 1

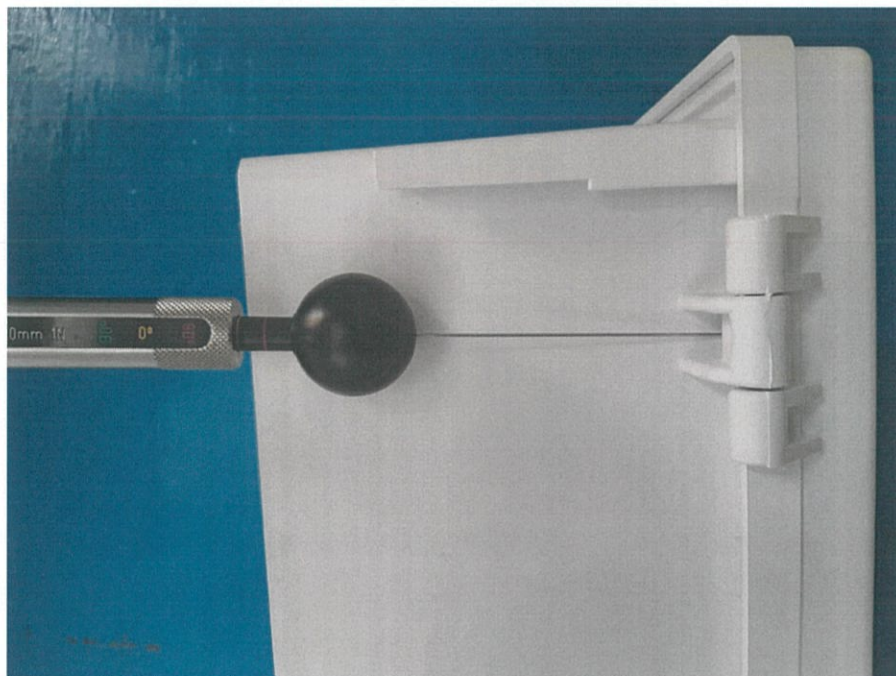
Photo No.4 : IP4X test wire of  $\varnothing$  1.0 mm

**Protected against access to hazardous parts with a wire test (IP4X)**

The test wire of 1.0 mm  $\varnothing$  shall not penetrate and adequate clearance shall be kept.

**Protected against solid foreign objects of 1.0 mm.  $\varnothing$  and greater (IP4X)**

The object probe of 1.0 mm  $\varnothing$  is pushed against or inserted through any opening of the enclosure with 1 N $\pm$ 10%

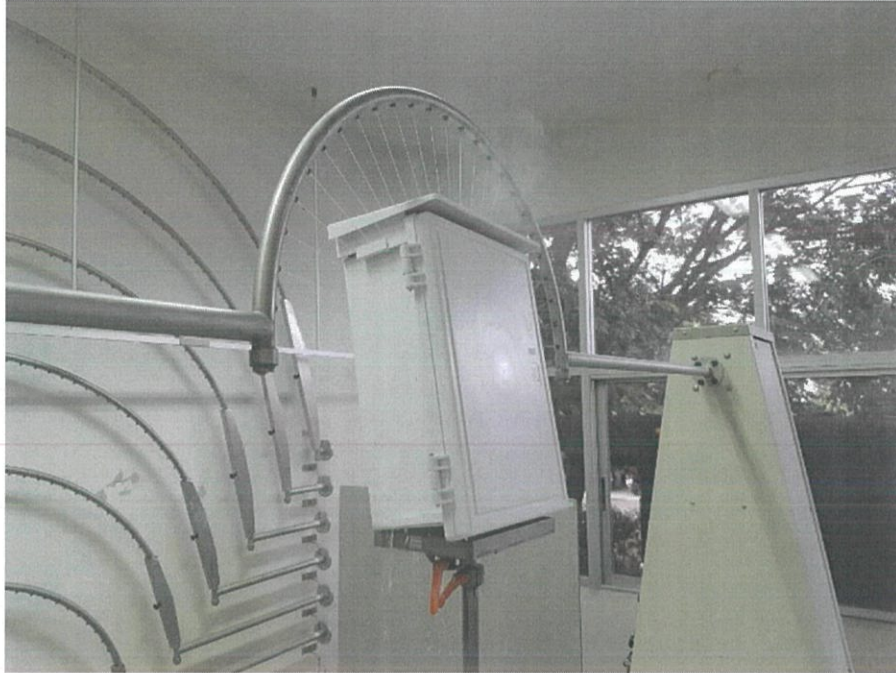
Photo No.5 : IPX4 Water test

**Protected against splashing water test (IPX4)**

The test is made using of test devices described in figure 4 The oscillating tube has spray holes over the whole 180° of the semicircle and total flow rate is adjusted as specified in table 9 of IEC 60529:2001

The tube is caused to oscillate through an angle of almost 360°, 180° on either side of the vertical, the time for one complete oscillation being about 12 s. The test duration of the test is 10 min.

The support for the enclosure under test is perforated so as to avoid acting as a baffle and the enclosure is sprayed from every direction by oscillating the tube to the limit of its travel in each direction.

The tube radius is 400 mm.

The flow rate is 1.80 lite/min.

Distance from spray holes to enclosure surface 200 mm.

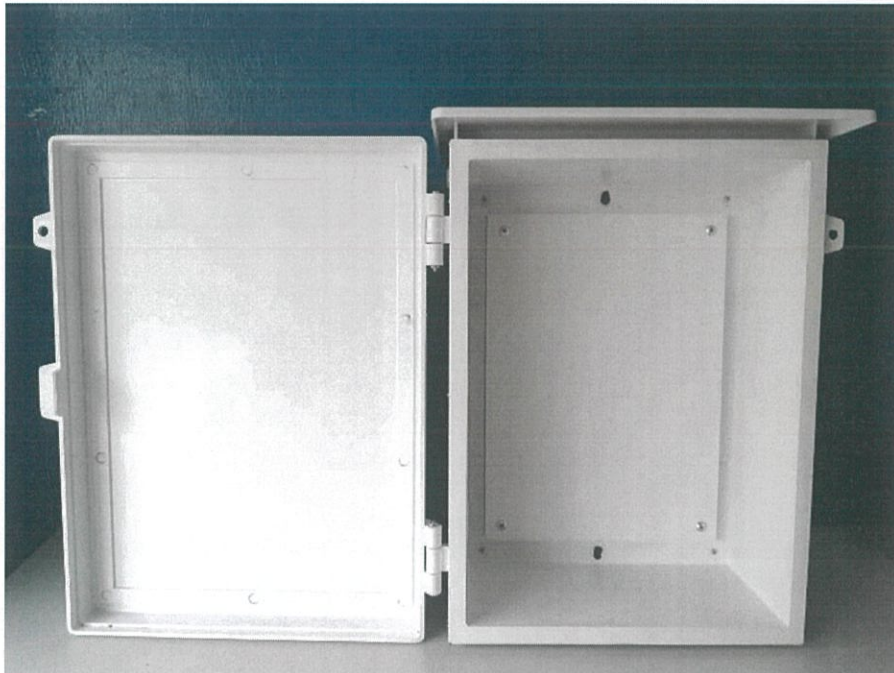
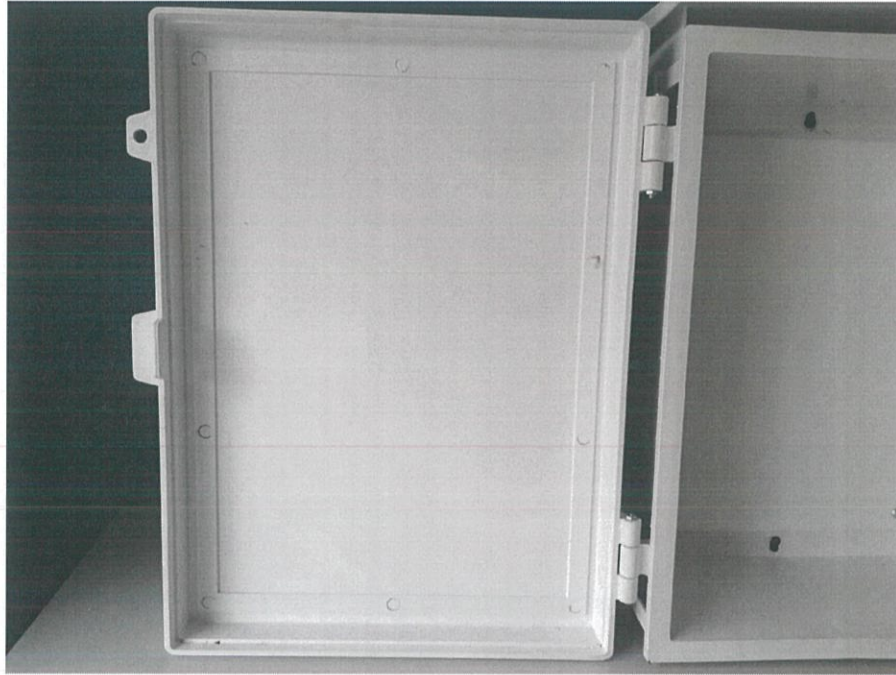
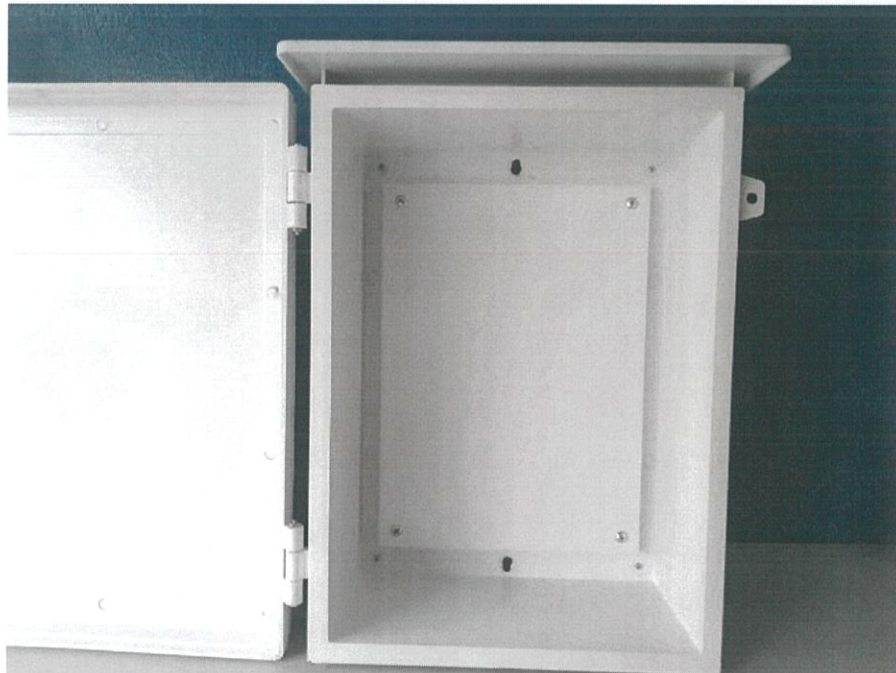
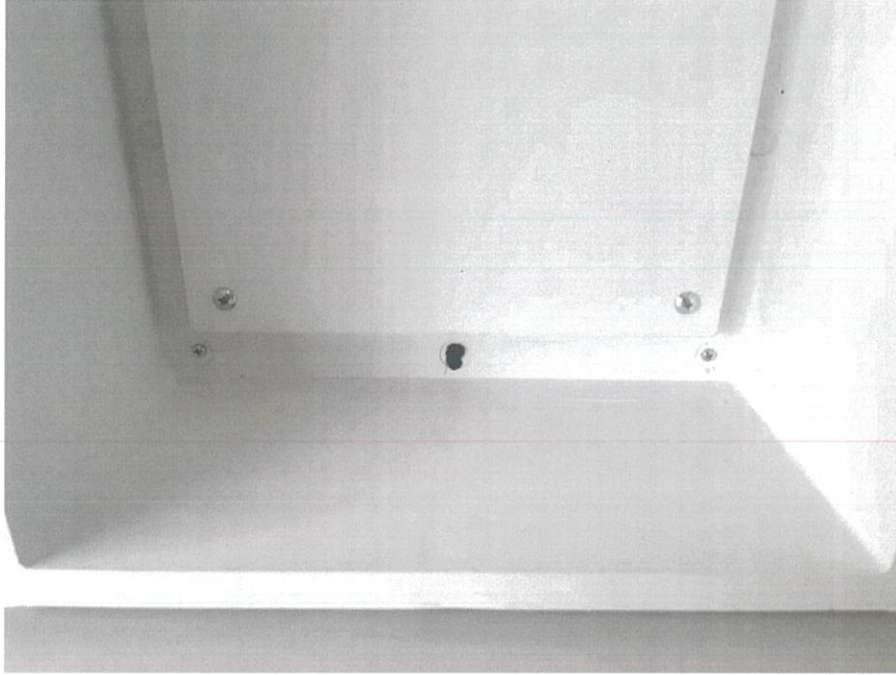
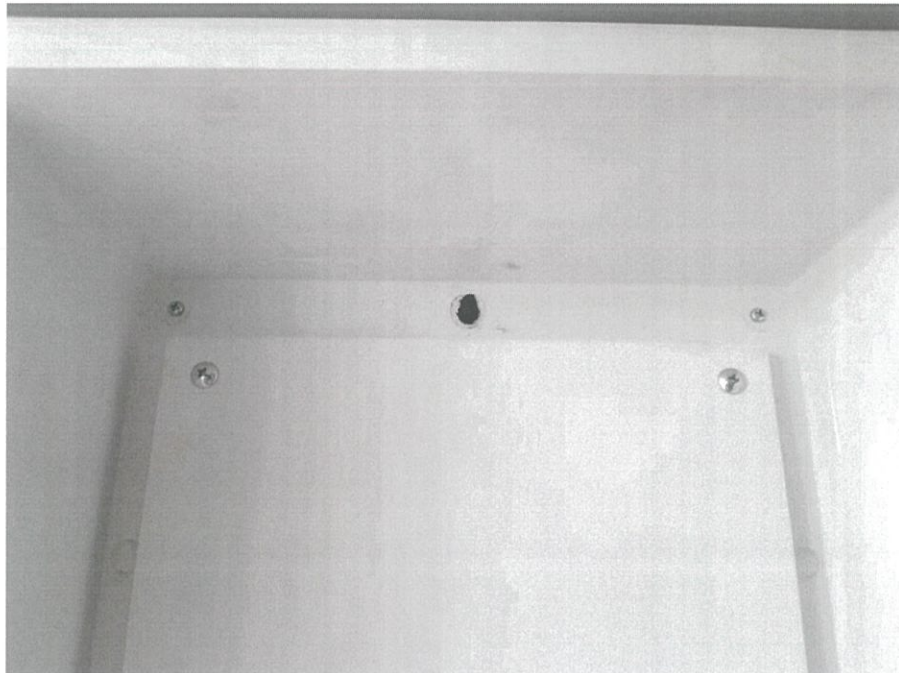
Photo No.6 : After test

Photo No.7 : After test

Photo No.8 : After test

Photo No.9 : After test

Photo No.10 : After test

Degree of protection			Result / Remark	Verdict	
Degree	Test	Definition			
IP44	IP4X	Protected against access to hazardous parts with a wire	The access probe of 1.0 mm $\emptyset$ shall not penetrate	The access probe of 1.0 mm $\emptyset$ , not penetrate to the enclosure.	P
		Protected against solid foreign objects of 1.0 mm $\emptyset$ and greater	The object probe of 1.0mm $\emptyset$ , shall not penetrate at all	The object probe of 1.0 mm $\emptyset$ , not penetrate to the enclosure.	P
	IPX4	Protected against splashing water	Water splashed against the enclosure from any direction shall have no harmful effects.	No water was found inside the enclosure.	P
